# HDP-D90

## Sound Manager & Firmware Update

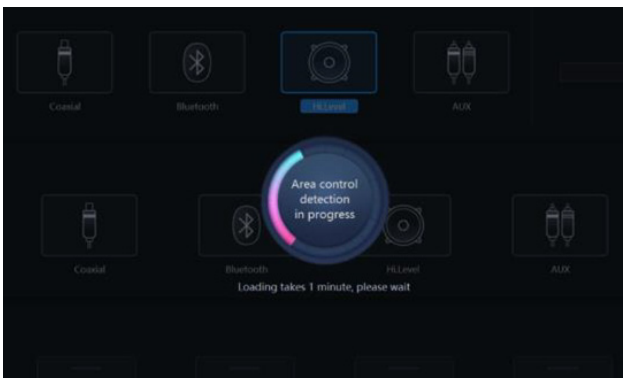
**Update resolves:**
Area Control Detection issue. (Internet connection always required when connecting to DSP Amplifier). This is an issue in areas where internet is not always available.
